Manhole Inspection Summary

Manhole # S2100_001MH

Location Address: **2323 OREM AVE**

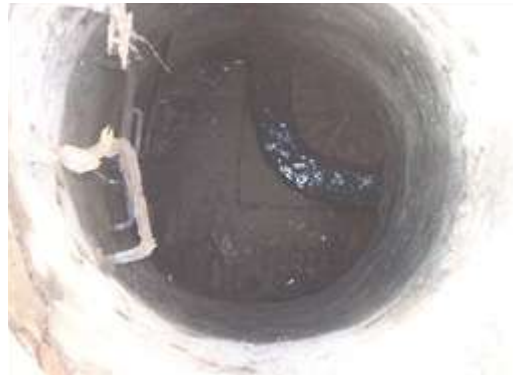
Top View

OFFSET CHANNEL AND DEBRIS ON BENCH

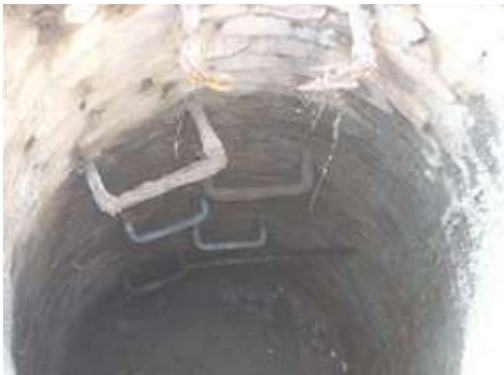
Defect 3

Steps Count: **5** Missing: **1** ☒ **Corroded**

CORRODED AND MISSING STEPS

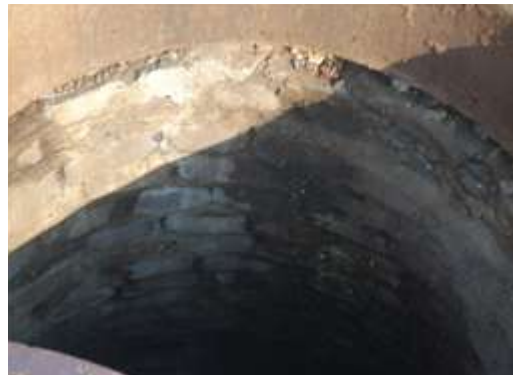
Defect 2

Condition: ☐ Sound ☐ Cracked ☐ Root Intrusion ☐ Loose Brick ☒ **Deteriorated**

Infiltration: ☐ None ☐ Joint ☐ Cracks ☐ Mortar ☐ Roots ☒ **Wall**

INFILTRATION AND DETERIORATION OF CORBEL

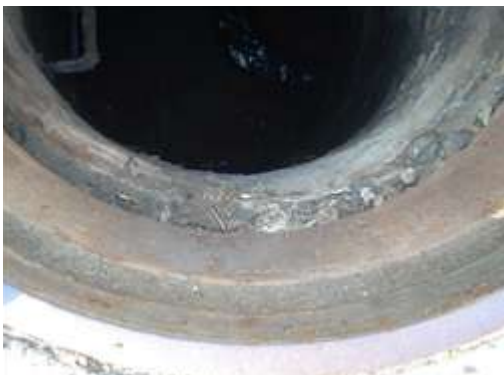
Defect 1

Frame Offset: **2** (in.) Condition: ☒ Sound ☐ Cracked ☐ Leaks

FRAME OFFSET
